ASDE-2 TRANSMITTER MODIFICATIONS

Federal Aviation Administration

14
REPORT NO. FAA-RD-72-32

SEPTEMBER 1972
FINAL REPORT

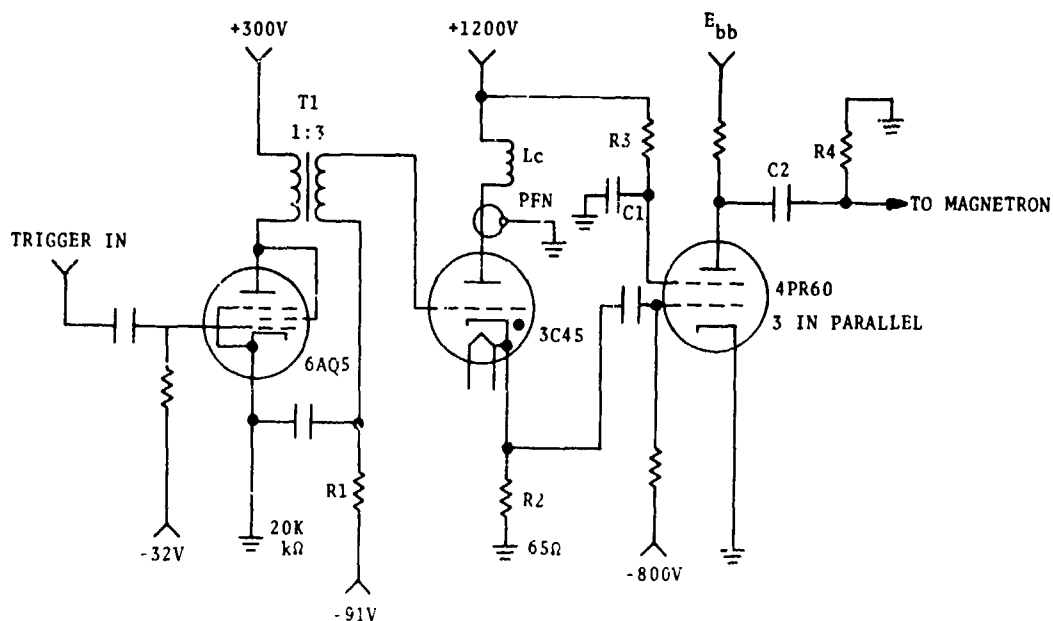
Figure 2. Simplified Modulator Schematic

The hydrogen thyatron type 3C45 is a very poor choice for the modulator driver. Life tests on this tube have shown that it will not survive for long at high pulse rates.^{1,2} In addition the radar circuit of which it is a part (Figure 2) is not well matched to its operating characteristics. For example, the stray capacitance that the 3C45 must charge during each pulse was measured and found to be 240 pico-farads, of which 80 pF is attributed to the filament transformer. The peak current required to charge this capacity is calculated to be about 24 amperes. The parallel load provided by the thyatron cathode resistor and the grid input circuit of the 4PR60 tubes is about 65 ohms at 1000 volts, leading to a resistive current component of 15 amperes. Thus, the 3C45 is required to deliver nearly 40 amperes peak when its rated maximum capacity is 35 amperes.

Attention is directed to Figure 2 and to the 65 ohm total resistance in the cathode of the 3C45. The reflected value of R_2 is now 50 ohms in the modified driver, which is a proper match for the pulse forming network made up of 8 feet of 50 ohm RG-8/U coaxial cable. An impedance match is most necessary if the output pulse is to return quickly to zero, a condition that is important when operating at a high PRR. The pulse appearing across the 50 Ω resistance coupled to the 4PR60's is 1150 volts positive when the driver is an 8765 and only about 1050 volts with a new 3C45 (see Figure 5). Thus, the 8765 drives the 4PR60's 350 volts positive compared to 250 volts for a 3C45. Some of the latter tubes could not drive the 4PR60's into the positive grid region at all, which resulted in very short tube life due to cathode contamination.
